THE RUSSIAN VIEW

Andrei Ulanov and Dmitry Shein

THE THE GOES TO WAR

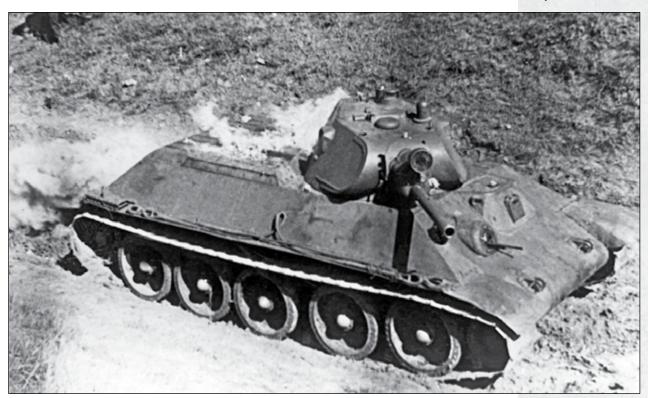
A T-34 during testing. A bottle with burning gasoline has been thrown on the engine compartment hatch.

But let's return to 1940. During the summer of 1940, tests to determine "engine thermal behavior, natural and artificial obstacle negotiation, tank performance, and tank-mechanism reliability under summer conditions" could not be carried out. On October 31, 1940, however, three mass-produced "thirty-fours" left Kharkov to drive the route Kharkov – Kubinka – Smolensk – Kiev – Kharkov. The tanks were required to travel two thirds of the 3,000 km route over dirt roads and off road. The tanks traveled 30% of the route at night and 30% over dirt roads and unbroken ground while in fighting order (with hatches closed). The test program was not limited just to travel—it again provided for testing of weapons, communications gear, and negotiation of natural and artificial obstacles, as well as for testing of the tank against antitank mines and for determining tightness "by pouring a flammable liquid over it."

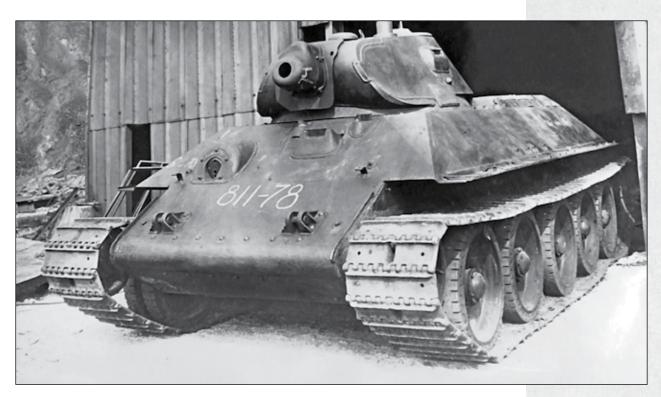
The tank prior to ballistic testing at Mariupol during the spring of 1941.

After the fall road test, the "proving ground tests on two T-34 tank hulls with turrets" (as they were called on the official list) held in April 1941 at the Ilyich Mariupol Factory's test range brought more bad news. Perhaps for the first time in the history of Soviet tank manufacture, a test range received not empty, odd-shaped armor boxes and individual armor plates but tanks that were "almost real"—the chassis had drive wheels, track adjusting wheels, and road wheels with suspensions. The tracks were tight, the final drives were armored, and the driver-mechanic's hatches and the vision blocks were installed. The hulls had "almost completely real" turrets mounted on race rings, along with a mantlet and armor for the gun system, a traversing mechanism with a stop, hatches, vision blocks, and plugs in the firing ports intended for firing revolvers. Ballistic tests were conducted using a 37 mm antitank gun M1930 (a licensed Soviet copy of the German PaK 36 "door knocker" gun), a captured Polish 37 mm Bofors gun, a 45 mm gun, and a "three incher."

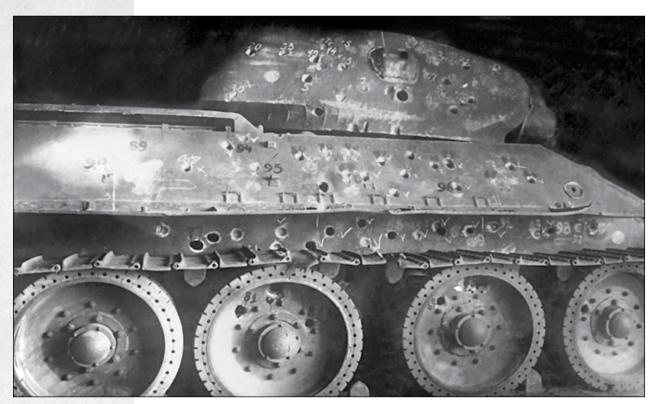
The tank after ballistic testing.

The tests lasted three weeks and gave the Soviet tank designers rich food for thought—which they did not always accept. The front armor plates creditably withstood a 76.2 mm armor-piercing shell fired from close range, but the sloped 40 mm side was defeated even by the 37 mm sharp-pointed armor-piercing projectile from a range of 175–250 m, revealing that the much vaunted "sound angle of slope" of the 40 mm side armor plate was noticeably worse at withstanding projectiles than was the 45 mm vertical armor plate on the lower side. Another unpleasant discovery was the identification of a significant hazard to the crew and the tank's mechanisms—armor plates defeated but not technically penetrated by a projectile:

It had previously been thought that a hull penetration smaller than a projectile's caliber would produce a single slug capable of killing or injuring only some of the crew or causing a small amount of localized damage within the tank that would not completely disable the tank. On the contrary, observations made during these tests established that shrapnel from a projectile's warhead that breaks apart when it passes through the armor enters the tank in addition to the cylindrical plug of armor. In addition, the slug frequently fractures into several pieces, and small pieces of shrapnel in addition to the slug spall off the armor. There were sometimes more than ten pieces of armor shrapnel and projectile fragments inside the hull when the hole was smaller than the projectile's caliber and most of the projectile remained outside the plate. Therefore, a hole smaller than the projectile's caliber is more dangerous for the crew inside the tank, its assemblies, etc., than previously thought; this type of defeat is relatively dangerous for the crew. Numerous cases of destruction within the hull caused by armor slugs were observed; for example, both of the soft carbonsteel side plates, which have a total thickness of 6 mm, were penetrated, as were oil tanks, radiators, fuel tanks, etc. These observations show that the slug travels at a high speed beyond the armor protection.

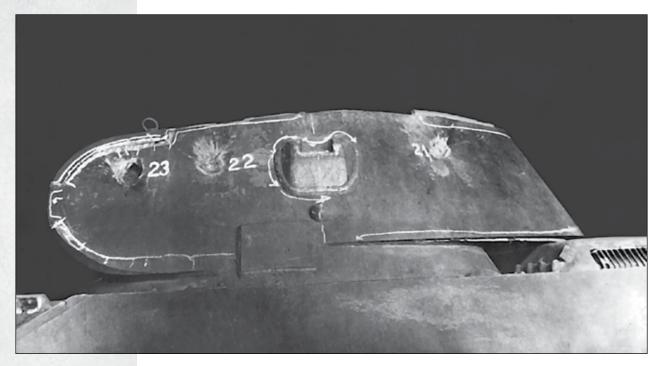
... Weld disintegration following a hit by the first 76 mm projectile to the side of the [welded] turret...

Three-inch high-explosive shells caused quite a headache—although the test reports record no penetration of 40–45 mm armor parts by a 76.2 mm HE shell:

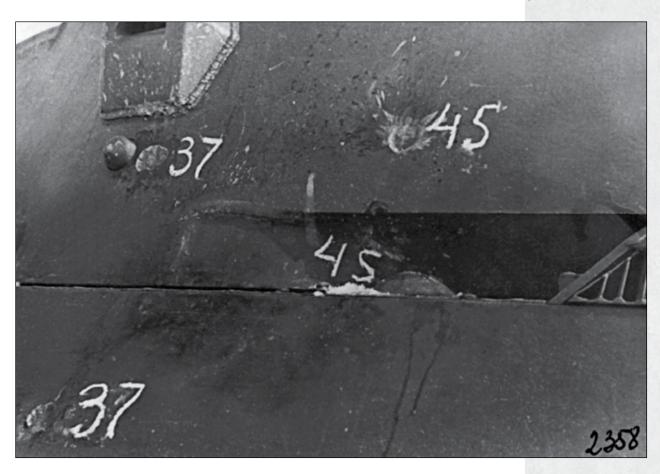
Damage to the side and turret of a T-34 struck by 37 mm and 45 mm armorpiercing projectiles during testing in the spring of 1940.

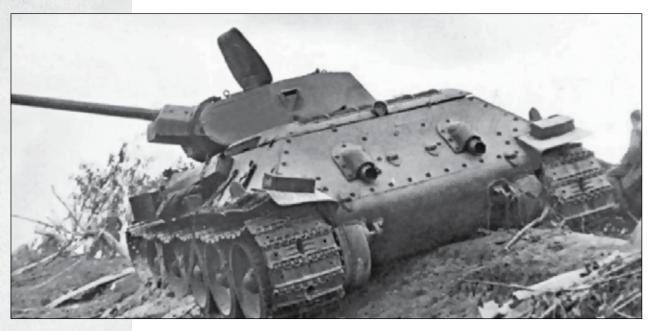
A T-34 disabled in combat in Ukraine during June 1941. Despite its outward appearance, this tank had burned—the rubber tire on the front left road wheel is burned.
